Title	Description of gas turbine plant
Topic & Summary	Gas turbine plant technical description and status assessment.

Document nr.	EPIT28537PR01	Type	Description
Issue	B	Status	DRAFT
Branch	EC – EECC Consulting	References	New Life
File	EPIT28537PR01B_Formentera.docx		
Keywords	Gas Turbine, GE, Formentera

This document provides a detailed description of the technical characteristics and condition of a GE FS5-1S gas turbine, serial number SN 147793. The turbine, relocated and refurbished in 1999, has a rated power output of 14,000 kW.

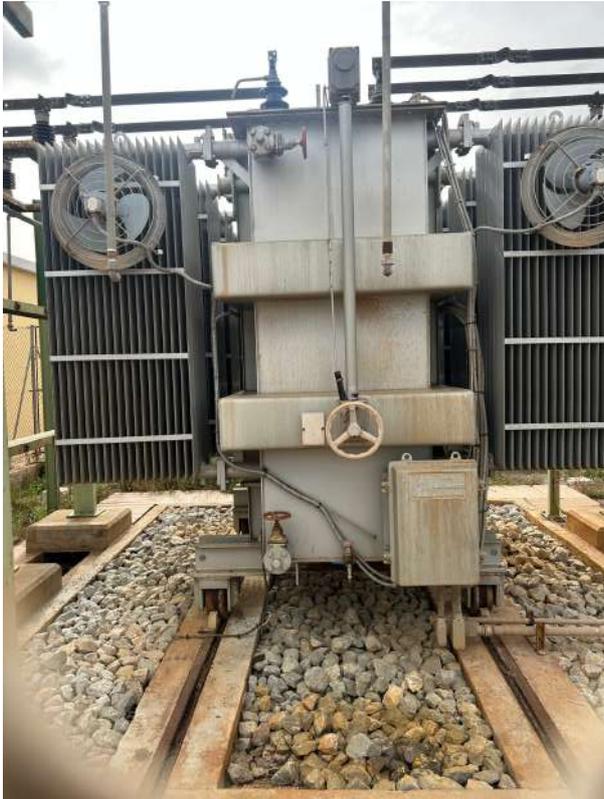
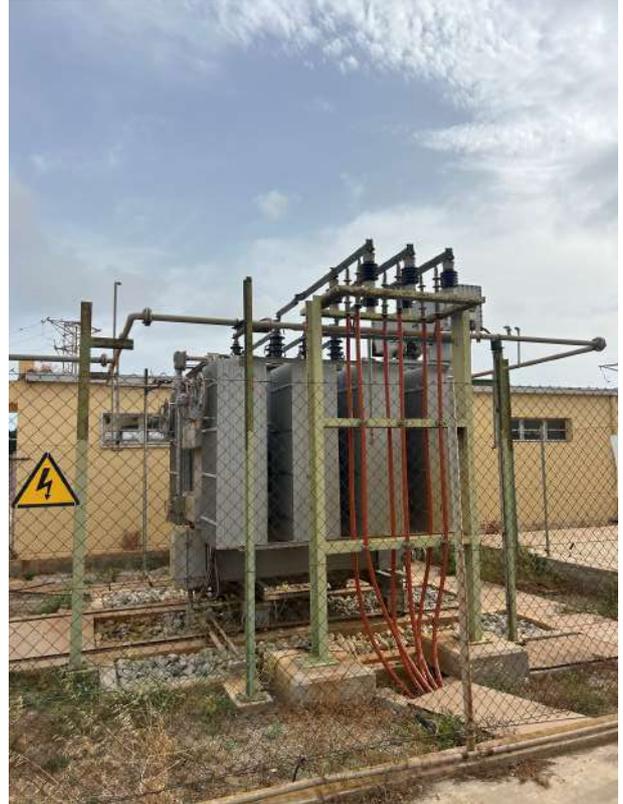
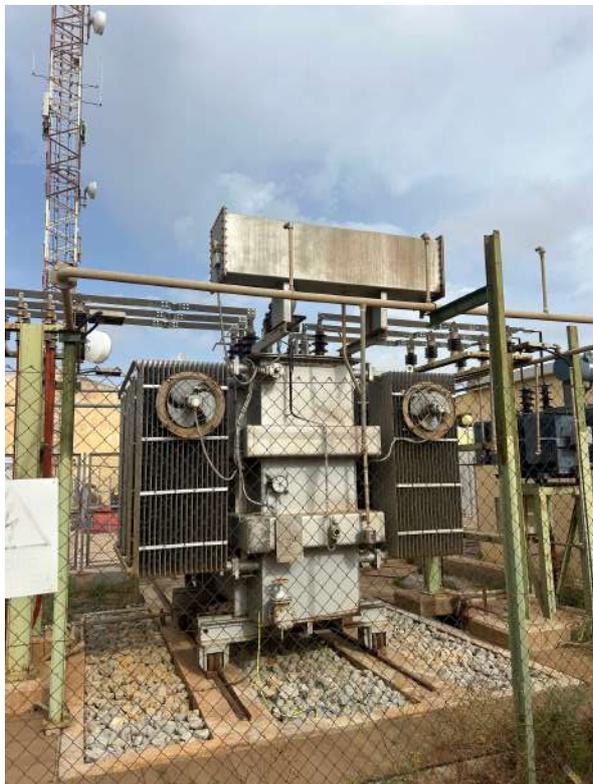
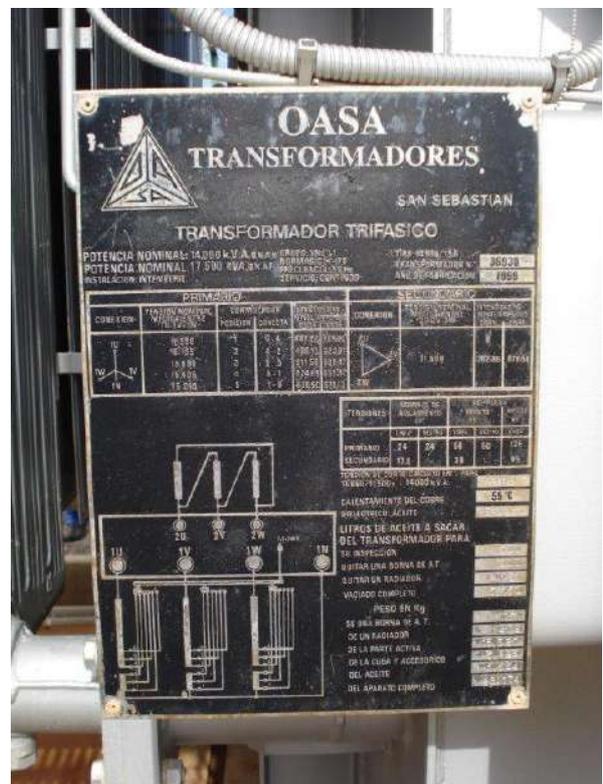
Figure 3 Main Transformer

Critical components – including the power transformer and auxiliary equipment – have undergone technical checks, the results of which have confirmed the positive and reliable condition of the whole system.

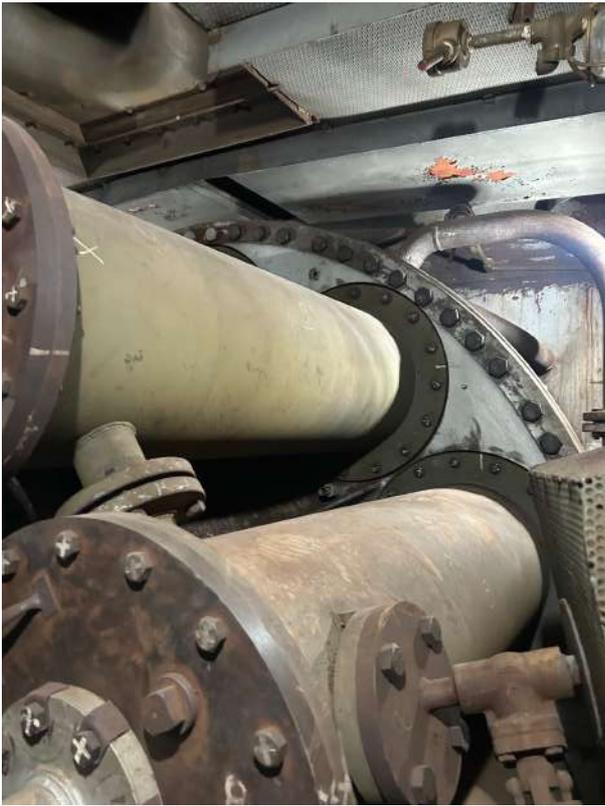
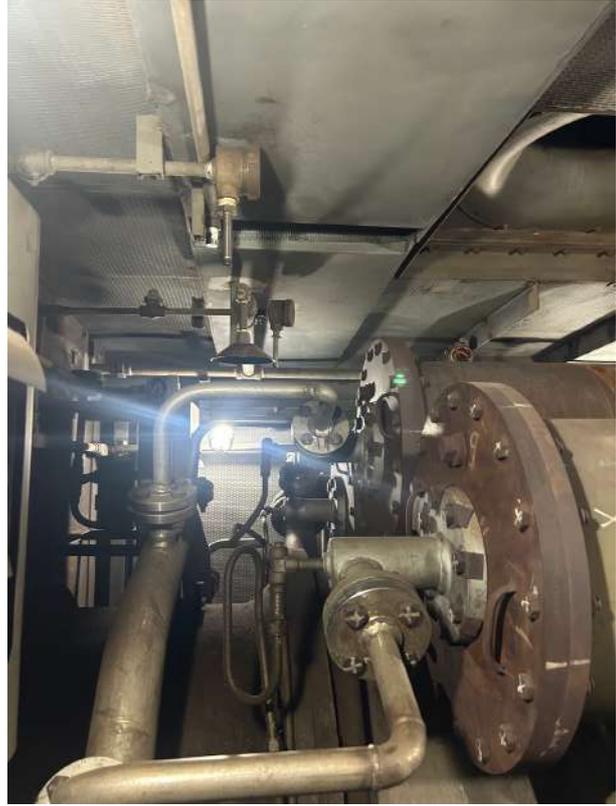
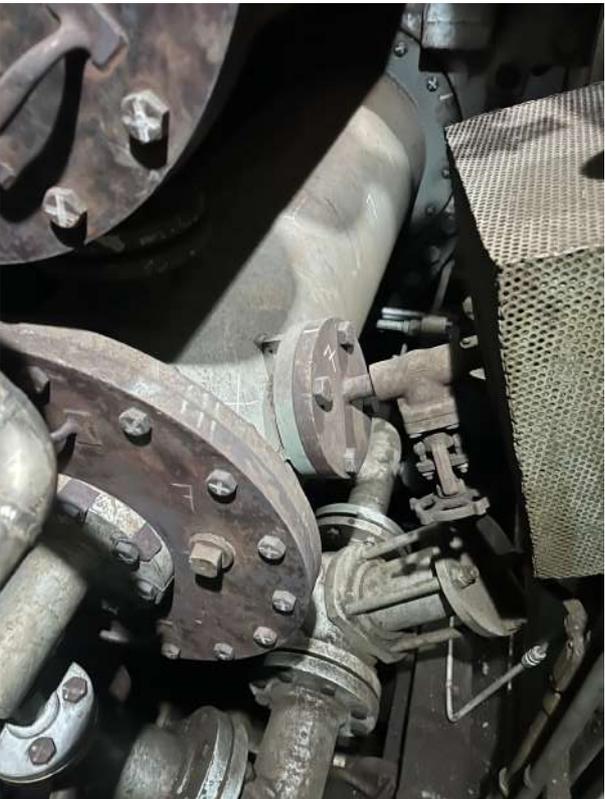
Figure 5 Combustion chamber

The intervention was required due to high vibration levels, excessive smoke at exhaust, and a borescope inspection which revealed a completely broken transition piece.

- **Combustion System:**
 - Replacement of all fuel nozzles and combustion liners due to erosion, carbon deposits, and thermal coating damage.
 - Complete replacement of transition pieces (one was fully broken, others severely worn).

- Inspection and cleaning of combustion cans, which were returned to service.
- **Hot Gas Path:**
 - Replacement of 1st and 2nd stage nozzles with refurbished GE components.

The intervention restored unit reliability and resolved the immediate issues affecting combustion performance, turbine efficiency, and lubrication. The unit is back in service under stable operating conditions, although follow-up actions are recommended for enclosure replacement and monitoring of the 1st stage buckets.
