| Title | Description of 2x130MW coal power plant |
| Topic & Summary | Coal fired steam turbine power plant technical description and status assessment. |

| Document nr. | EPIT28549PR05 | Type | Description |

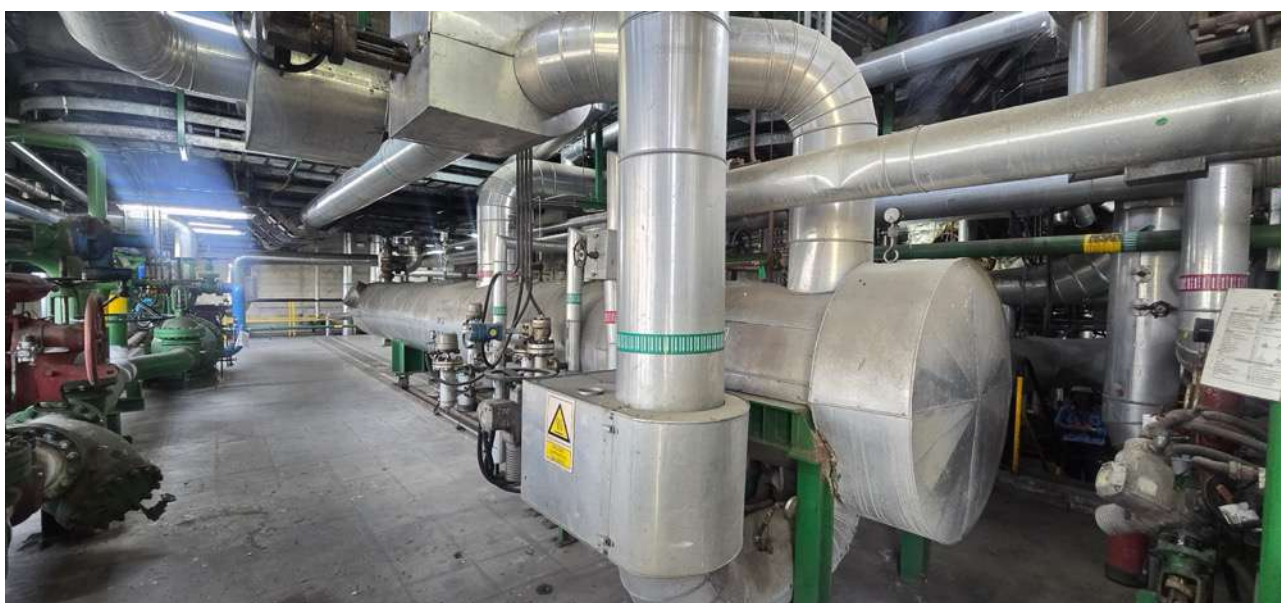
Figure 8: detail preheaters. All are visually in perfect condition.

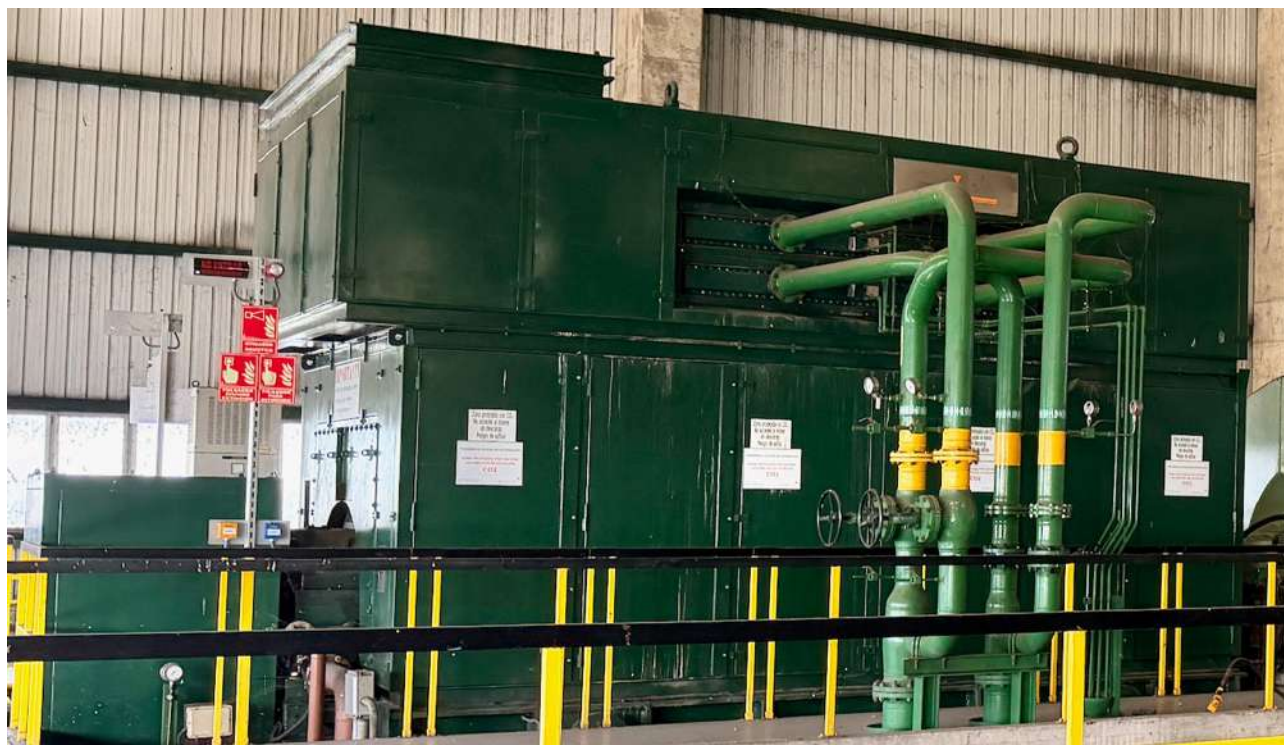
Figure 12: overview of the generator with its exciter.

Electrical testing of the rotor produced excellent results. Insulation resistance measurements, pole balance tests, impedance measurements and Rotor Shorted Turn (RSO) tests all met acceptance criteria and revealed no evidence of winding defects or insulation failures.

The exciter was also found to be in satisfactory condition. Although dust contamination was observed, no winding damage or structural defects were identified. One rectifier diode exhibited abnormal leakage current and was replaced during the outage, after which all electrical test results became satisfactory.

Overall, Unit 4 demonstrates very good electrical characteristics and satisfactory mechanical condition.

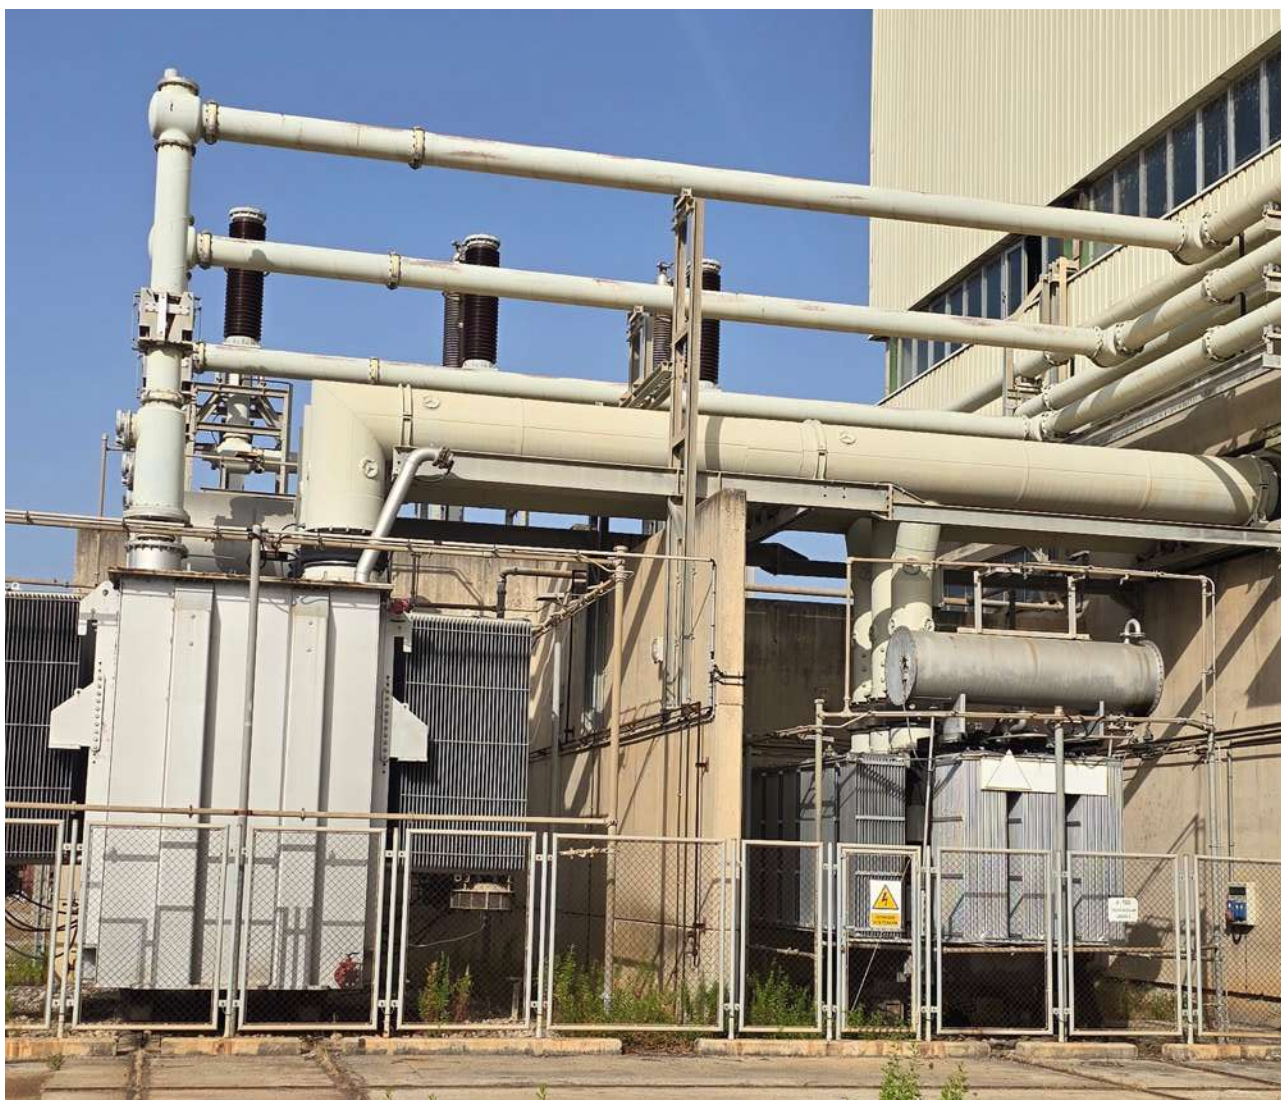
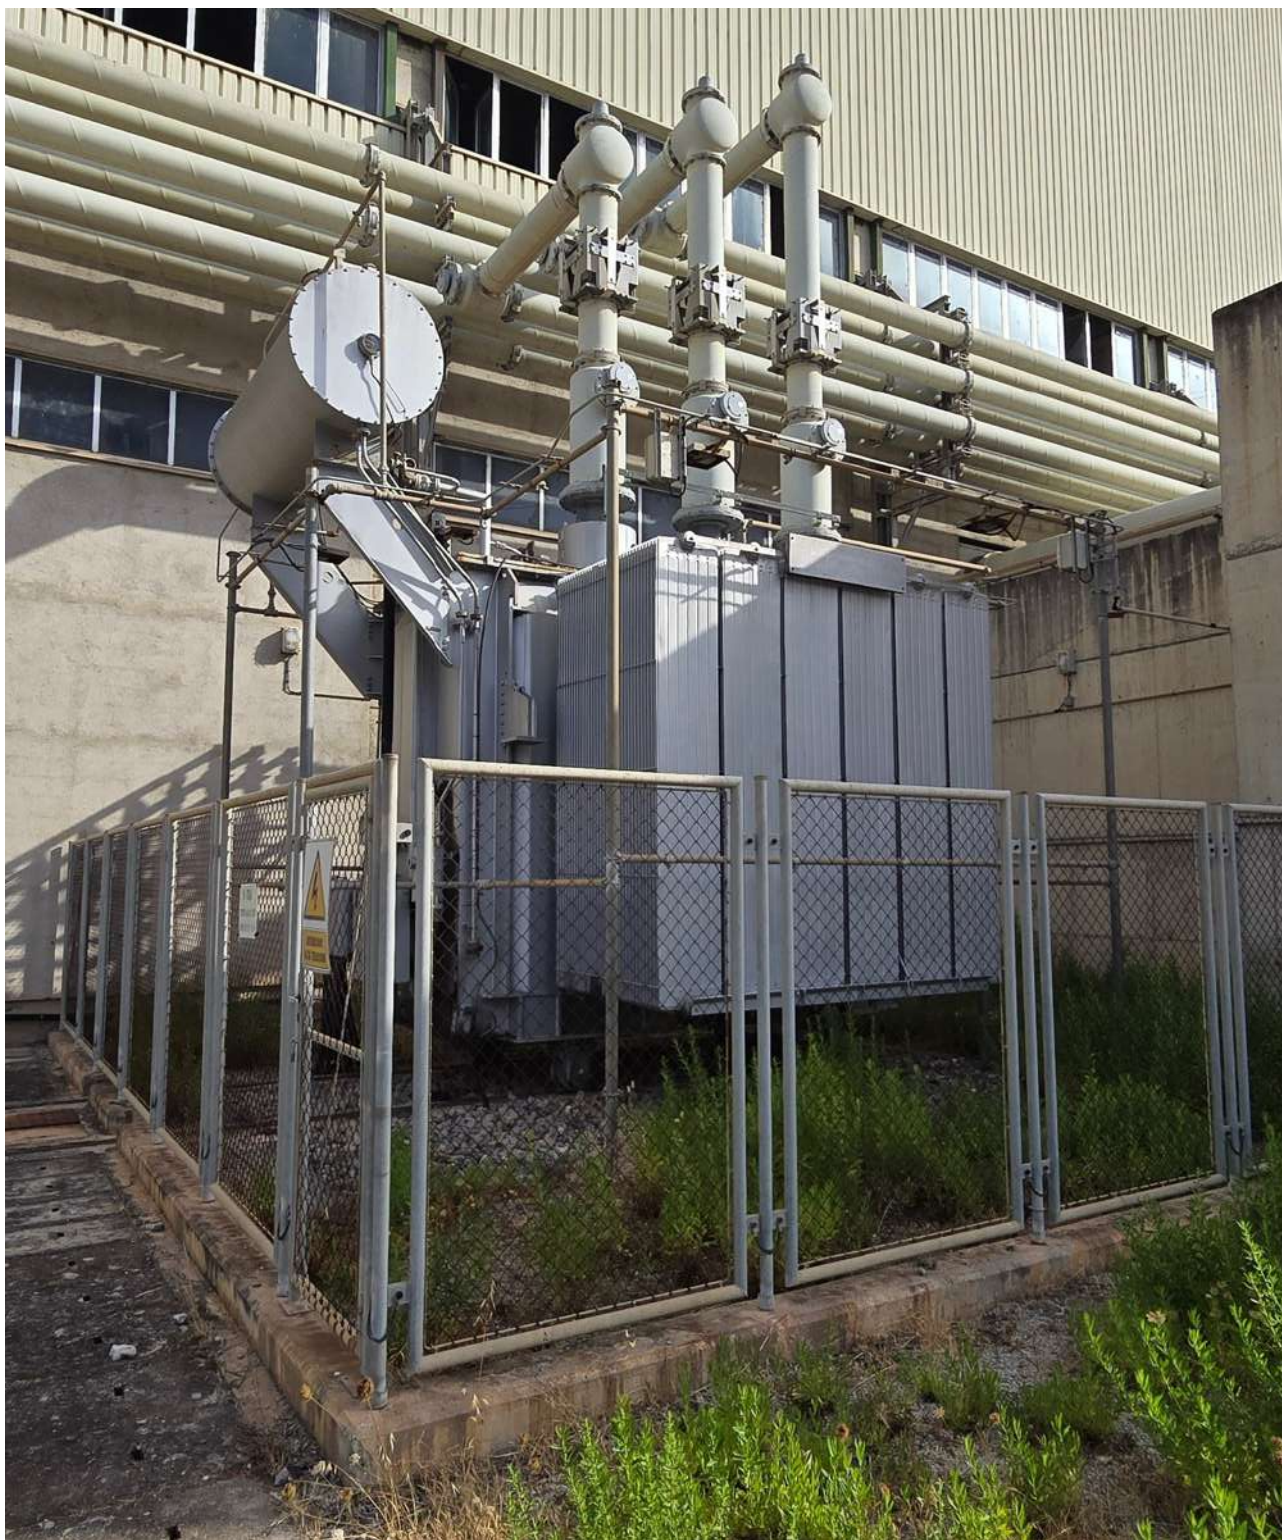
Figure 13: overview of transformers

The main generator transformer was manufactured by General Eléctrica Española (GEE) in 1979 and is identified as type TPAV 150000/245. The transformer is rated at 150 MVA under forced-air cooling and 112.5 MVA under natural cooling conditions. The voltage ratio is 245 kV / 12.3 kV, providing the connection between the generator terminals and the high-voltage transmission network.

Based on the nameplate information, both transformers appear adequately sized for their intended functions and feature industry-standard vector group configurations. However, due to the advanced age of the generator step-up transformer, particular attention should be given to asset-life management activities and transformer health monitoring programmes, as its condition will be a key factor influencing the long-term reliability and availability of the generating unit.

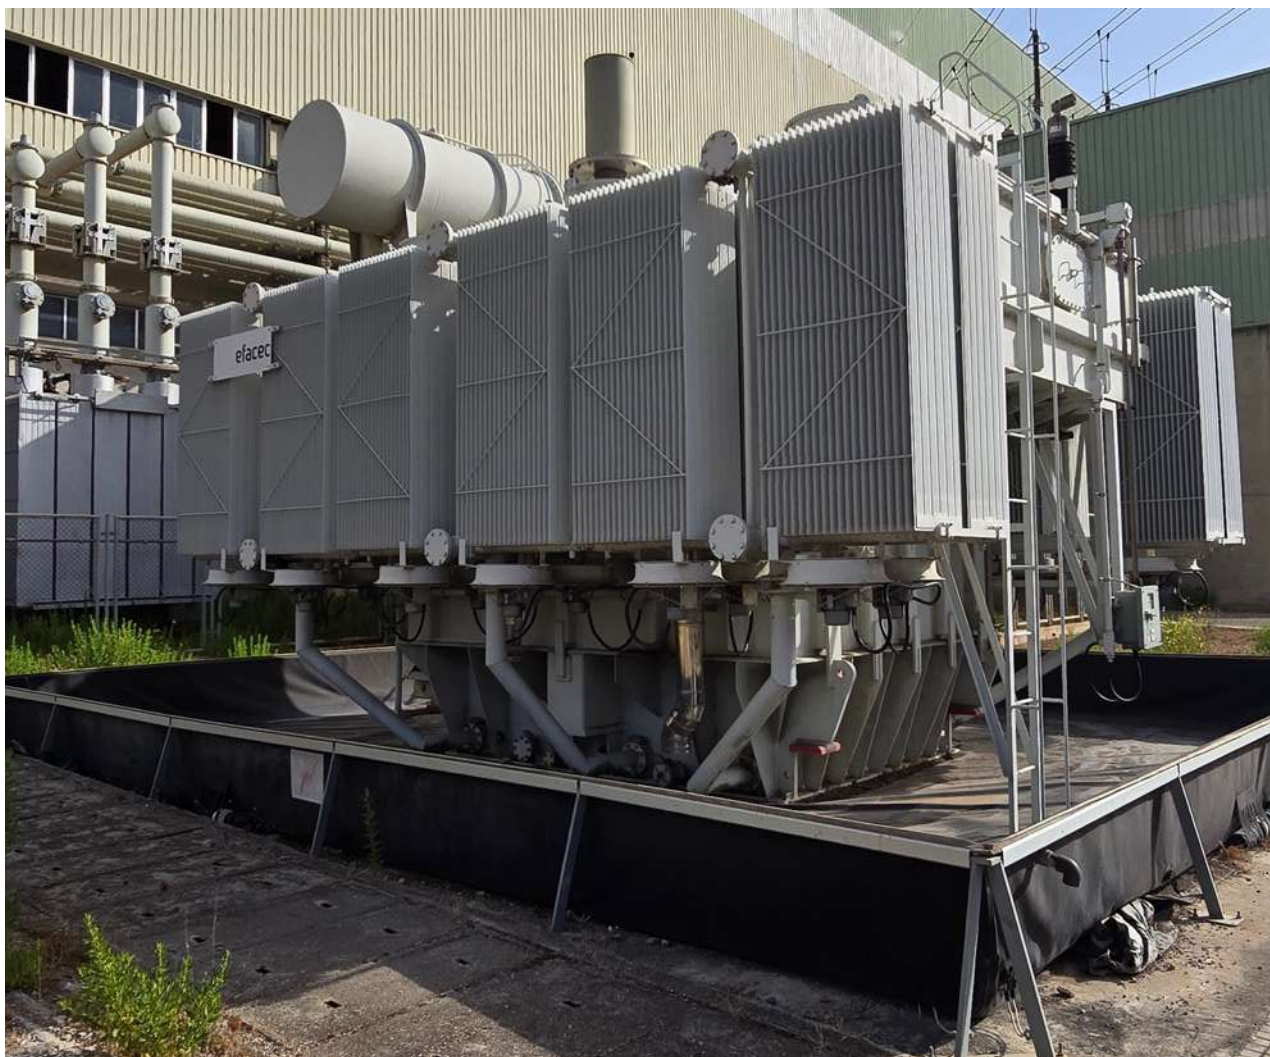
Figure 15: overview of spare transformer

- 130 MVA under ONAN cooling conditions.
- 162 MVA under ONAF cooling conditions.
- 245 kV / 11.5-12.3 kV nominal voltage ratio depending on the selected operating position.
- 50 Hz frequency.
- YNd11 vector group.

A significant positive aspect identified during the assessment is the availability of a dedicated spare generator step-up transformer manufactured by EFACEC in 2012. The spare unit is rated at 130 MVA (ONAN) and 162 MVA (ONAF) and is specifically designed to be compatible with the generating units installed at the plant. As such, it represents a strategically important asset that can be deployed in the event of a major failure of one of the existing generator transformers.

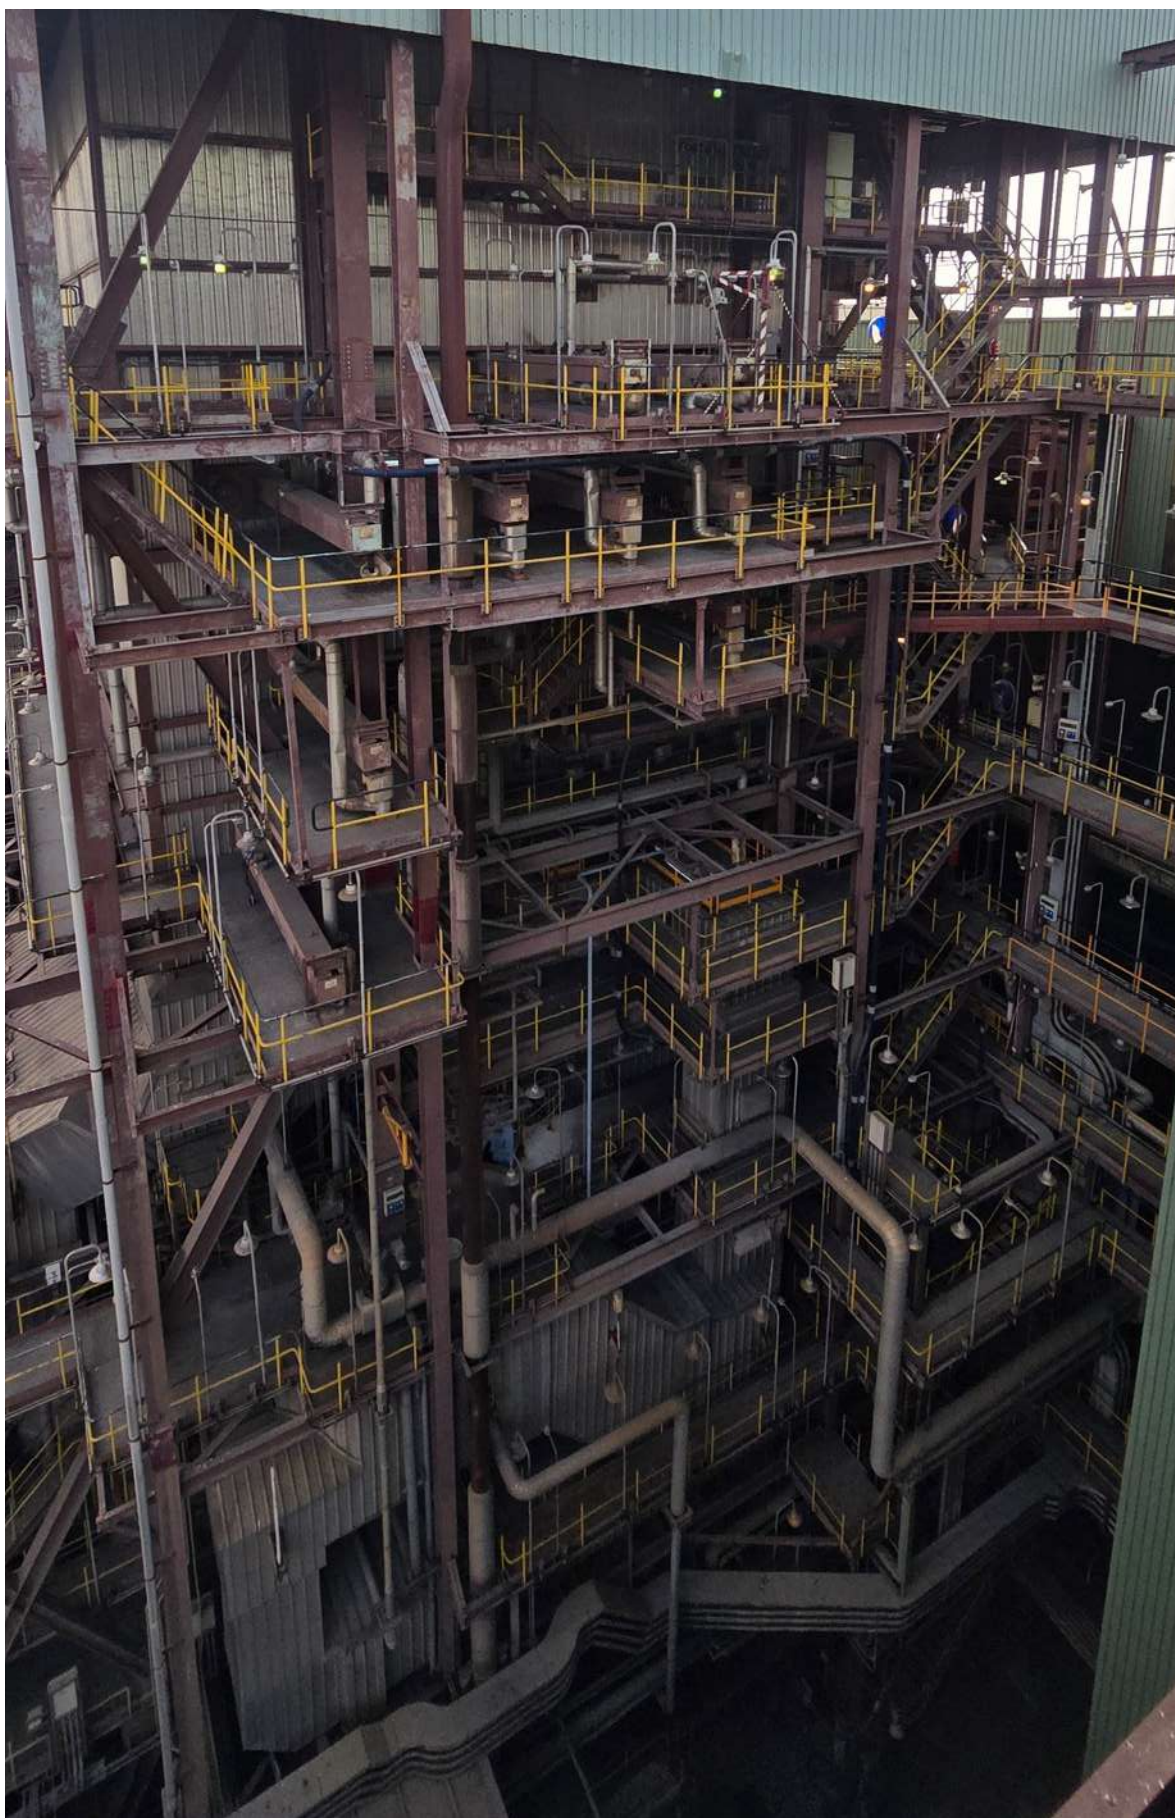
Figure 21: side view of the boiler Unit4

The inspections performed during the 2023 and 2024 outages indicate that both boilers remain in generally good condition and suitable for continued operation. Comprehensive non-destructive examinations performed during the major outages found no evidence of significant cracking, creep damage, structural deterioration or other critical defects affecting the pressure parts. Thickness measurements, metallographic examinations, magnetic particle testing, liquid penetrant testing and ultrasonic inspections confirmed that the majority of components remain within acceptable service limits.

Some age-related degradation mechanisms were identified, including localized oxidation, corrosion, erosion in sootblower areas, isolated low wall-thickness readings on selected water-wall and superheater tubes, and deterioration of protective tiles and refractory materials in high-wear zones. However, these findings were limited in scope, did not compromise the integrity of the boilers, and are being addressed through routine maintenance and periodic monitoring programs.

Overall, the condition of Units 3 and 4 can be considered good for their service age, with no major findings requiring immediate corrective action. Based on the inspections performed, both boilers are considered capable of maintaining safe and reliable operation until the next scheduled major outage, provided that the recommended monitoring of erosion-prone and corrosion-prone areas continues.

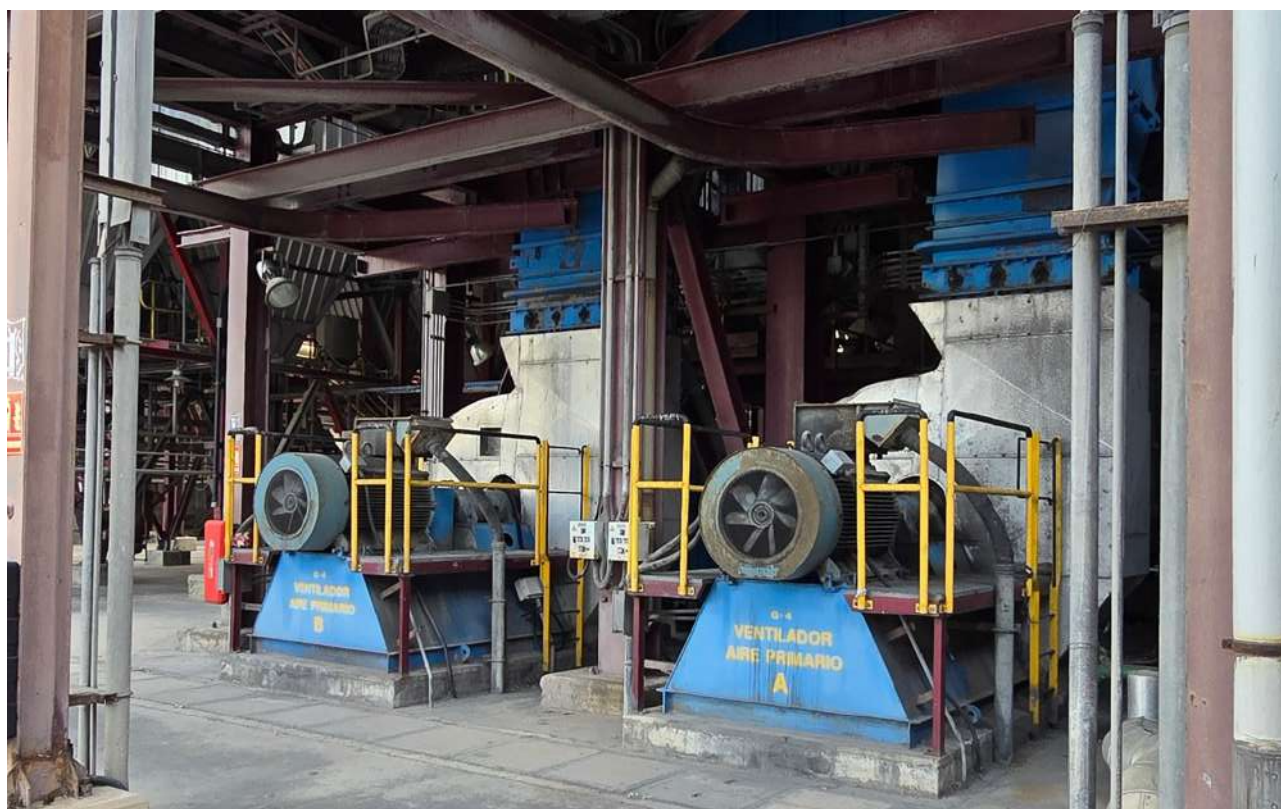
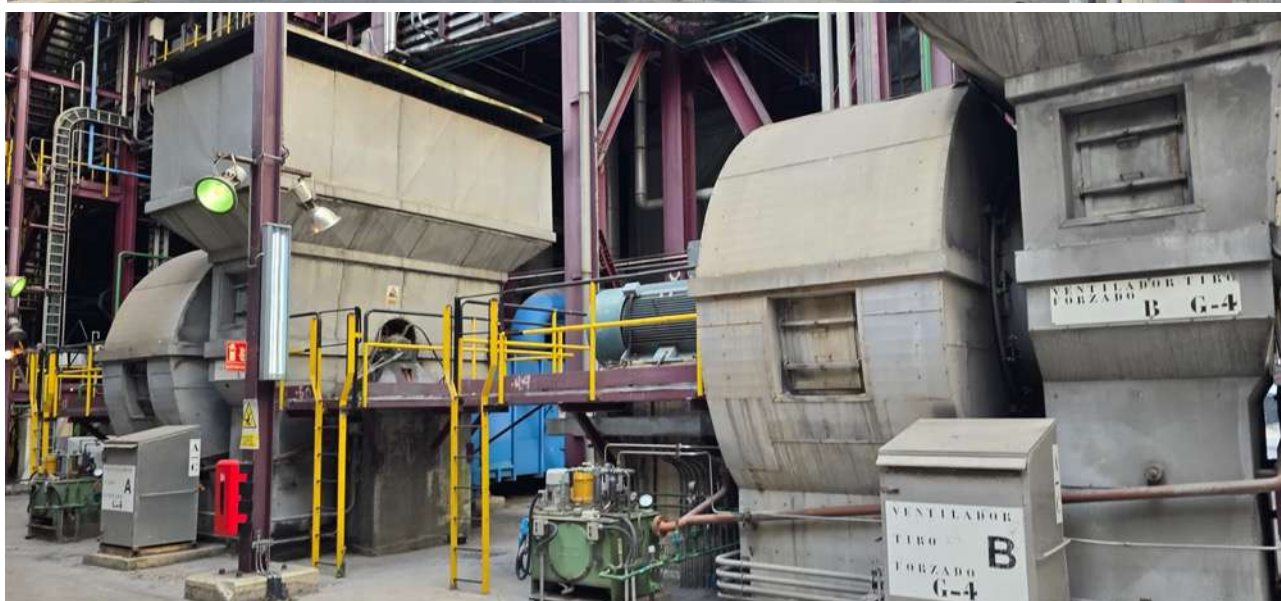
Figure 23: the sooth blowers are installed below the boiler, the fresh air blowers on the sides

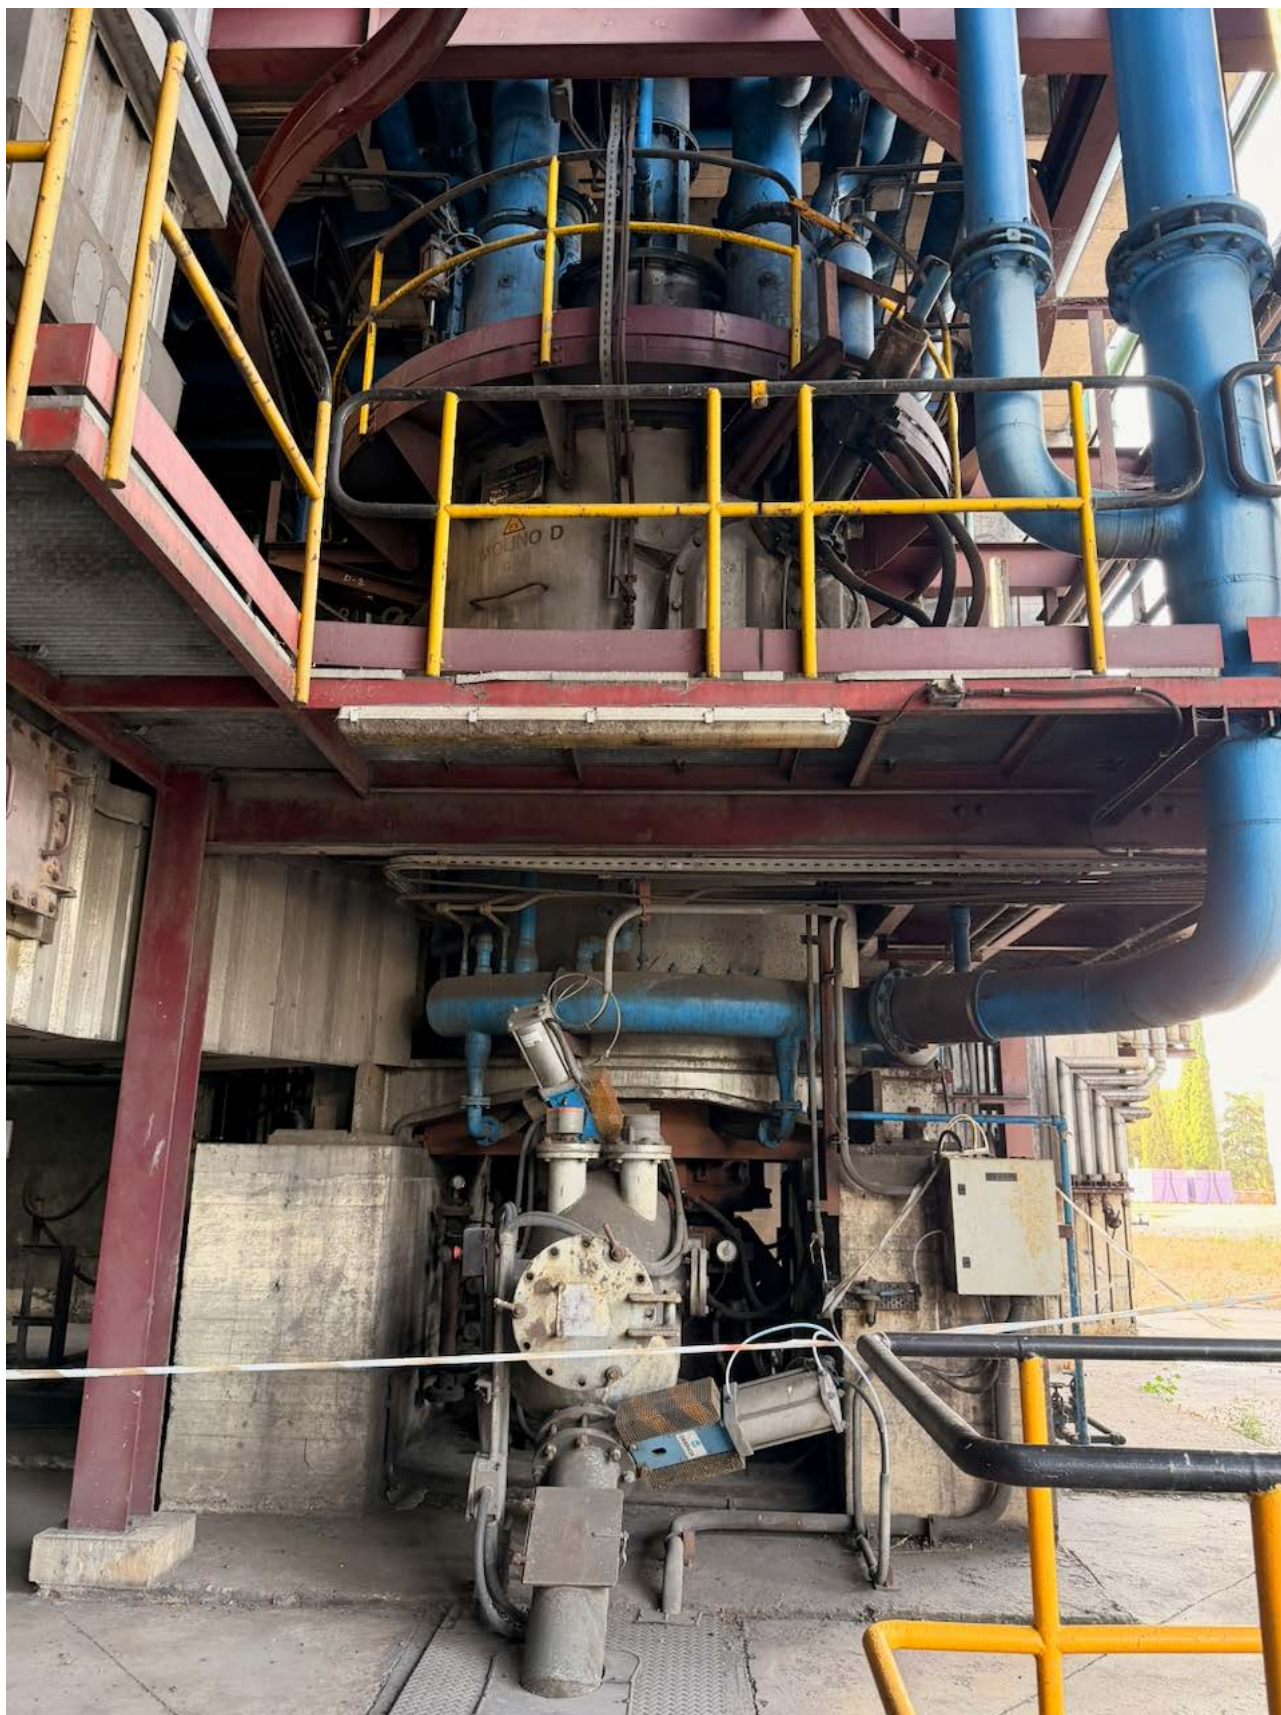
Figure 24: coal mill. Perfectly cleaned.

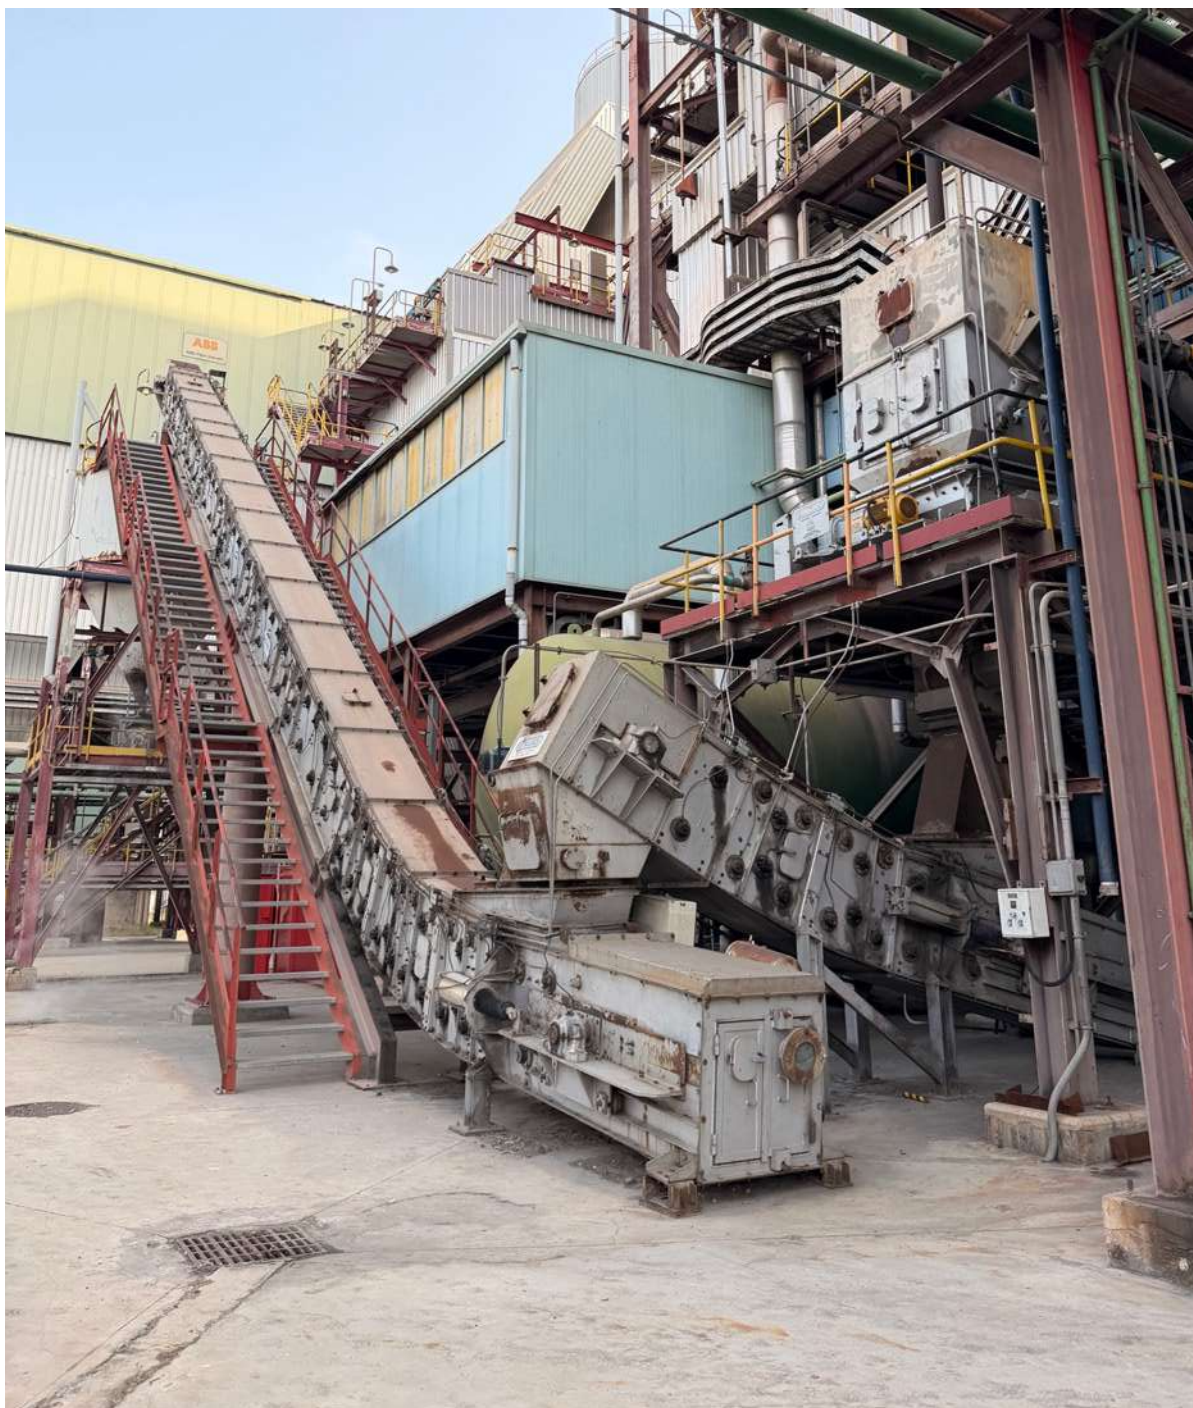
Figure 26: ash conveyor

The ash handling system provides a dry ash cooling and extraction solution, reducing water consumption and improving environmental performance.
